Return of the Torbryan two

Rachel Morley goes behind the scenes to discover the panel repair work undertaken at Holy Trinity, Torbryan

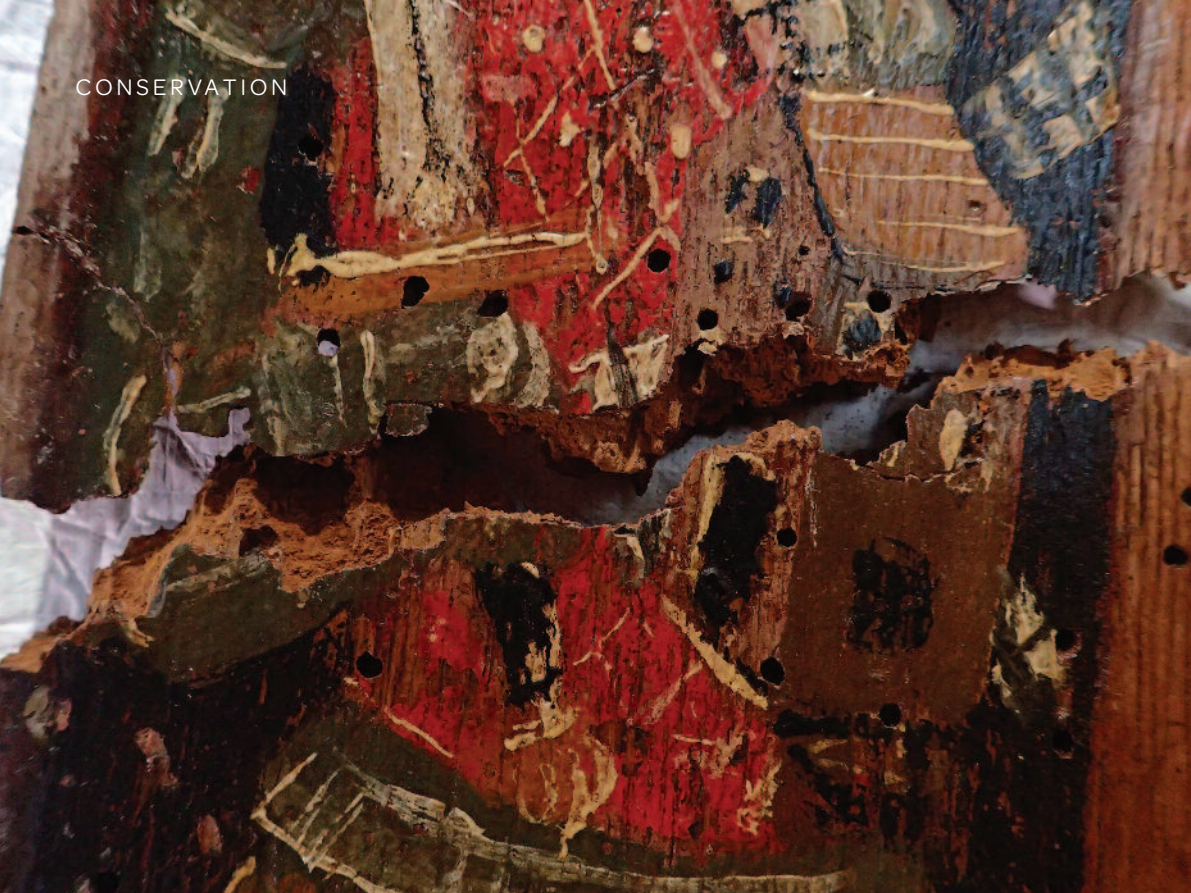
Above
Damage to the St Victor panel
(Eddie Sinclair, ACR)

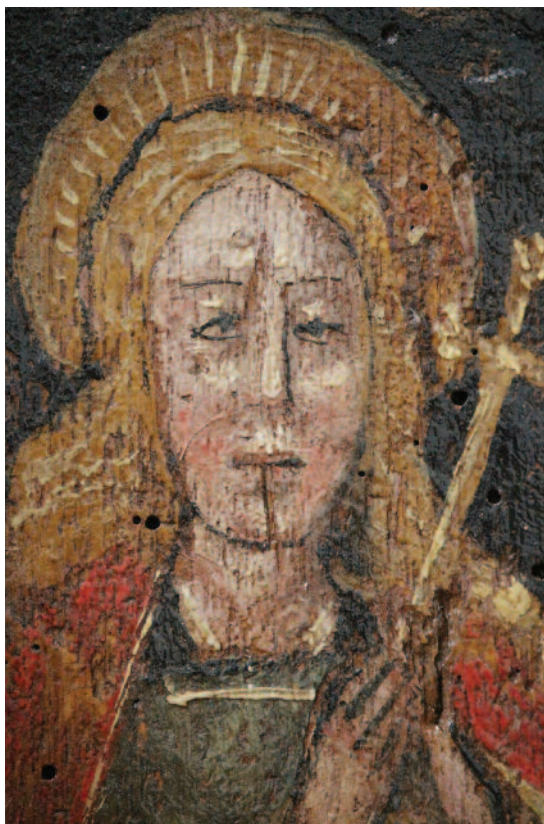
Above left
St Margaret of Antioch
following conservation
(Rachel Morley/CCT)

The fragments were now – to everyone's relief – in a stable state, and work to stitch the scenes back together could begin. For this, thickened fillers were used to support vulnerable edges and blend with the surface texture of the panels. Bridging fractures and filling surface losses, these mixtures were gradually built up before an isolation layer was applied and new decoration was integrated with the old. This isolation layer is essential for separating new work from original elements, meaning that the conservation work can be easily read and, even more importantly, can be reversed in the future without affecting the underlying surface. To respect the panels' hard-earned patina, new repairs were only toned in where they were particularly disfiguring or distracting.

The next challenge was to preserve as much of the original paintwork as possible. Working under magnification, Eddie painstakingly injected minute quantities of acrylic resin solution under delicate loose and flaking paint, to stick the lifted paint-film to the surface of the panel. Each flake was then gently laid back into position and planed with a heated spatula. Once the surfaces were secure, a dammar resin varnish was applied to protect the paintwork and re-saturate the rich colour palette.

Following these repairs, Stuart installed bespoke oak battens to the backs of the panels to provide additional support, further enhanced by specially designed stainless steel straps.

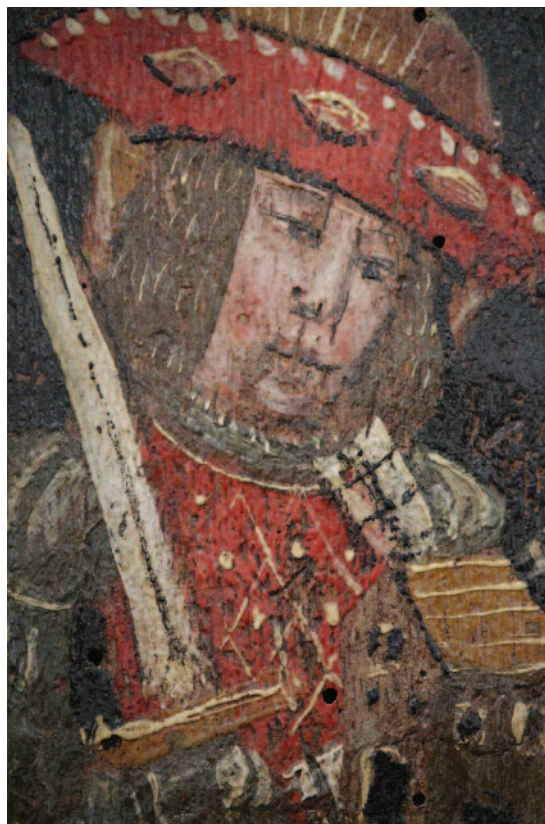
Above right
St Victor of Marseilles
following conservation
(Rachel Morley/CCT)

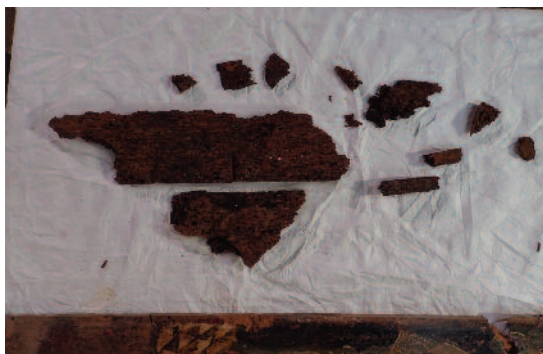
Above right
Retrieved panel fragments
(Eddie Sinclair, ACR)

Hacked from their frames, the panels and paintwork now cracked and crumbled. Indeed, such was the state of decay that, upon recovery, it was discovered that their thief had undertaken some conservation work of his own, crudely sticking fragments back together with PVA glue and pinning a cardboard photo-frame to the reverse. Needless to say, these are not methods which CCT would endorse.

reassembled and realigned like a complex jigsaw puzzle.
