# Bats in Churches: Objective Assessment of Associated Damage Mechanisms

This paper presents the preliminary results of research into the damage mechanisms involved when droppings and urine from insectivorous bats come into contact with a range of materials found within historic churches. It places the research in the wider context of conservation initiatives affecting both bats and historic church buildings in the UK.

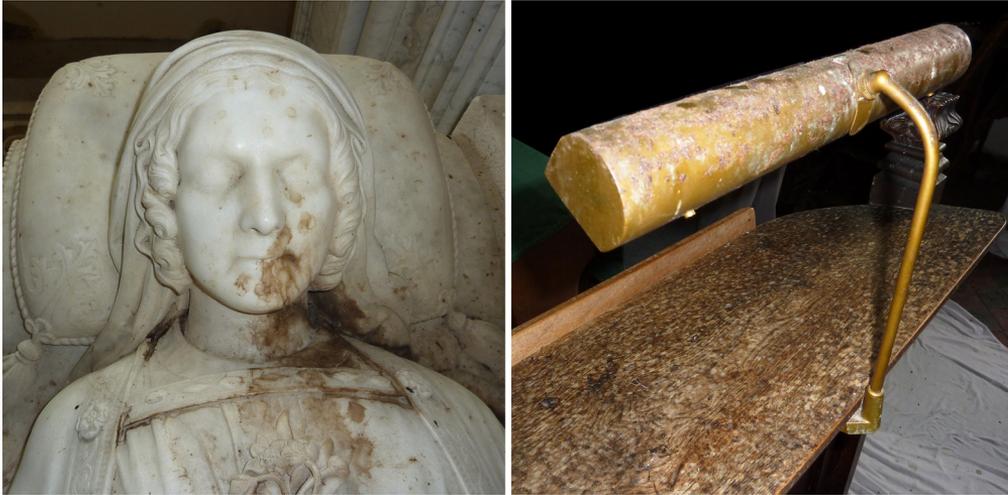
**Fig. 1:** Left, this marble funerary monument was situated under a bat roost, the staining has been caused by bat droppings and urine in combination. Right, this lectern shows the characteristic white spotting found on wooden surfaces caused by bat urine, the associated reading light is badly corroded.

For many years, bats have been thought to be responsible for some types of deterioration to the historic fabric of churches. However, for materials other than wall paintings, for which some research has been undertaken (Paine, 1991), our current understanding of bat related damage extends no further than being able to observe corrosion of metals, pitting of polished stone, white marks on varnished or polished wood surfaces and dark staining on pale coloured porous materials such as alabaster (**Fig. 1**). We do not

actually understand why this deterioration has occurred.

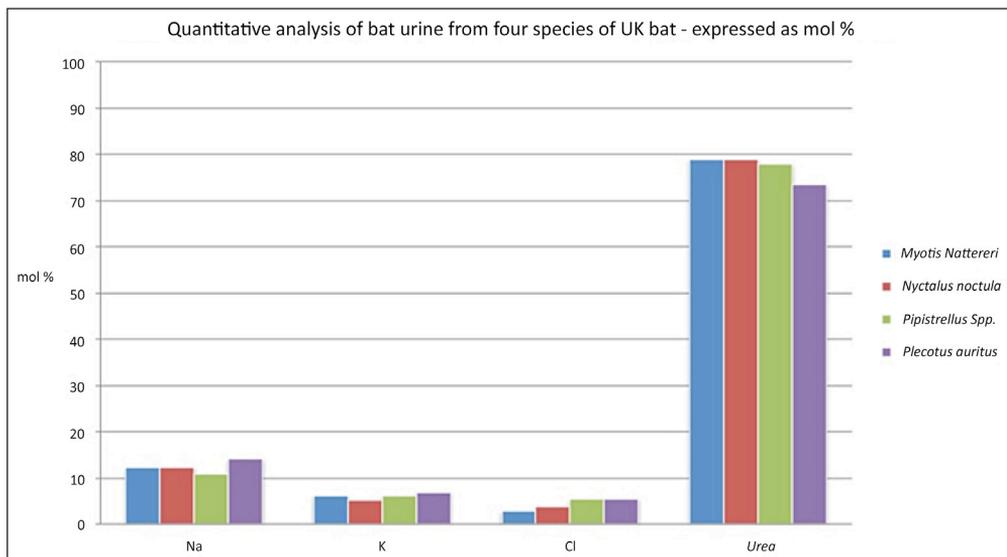
**Fig. 2:** Graph showing quantitative analysis of urine from four different species of bat converted to relative molar percentages for each species.

species examined. However, by expressing the concentration of the solute in each sample as molar percentages (i.e. expressing the different analytes as quantities relative to each other) (**Fig. 2**) it can be seen that the components of the bat urine analysed show a good degree of consistency across the four species, with little to no variance beyond the calculated standard deviation. What this means, is that urine composition is broadly consistent across all four species, yet the concentration of the urine is not.

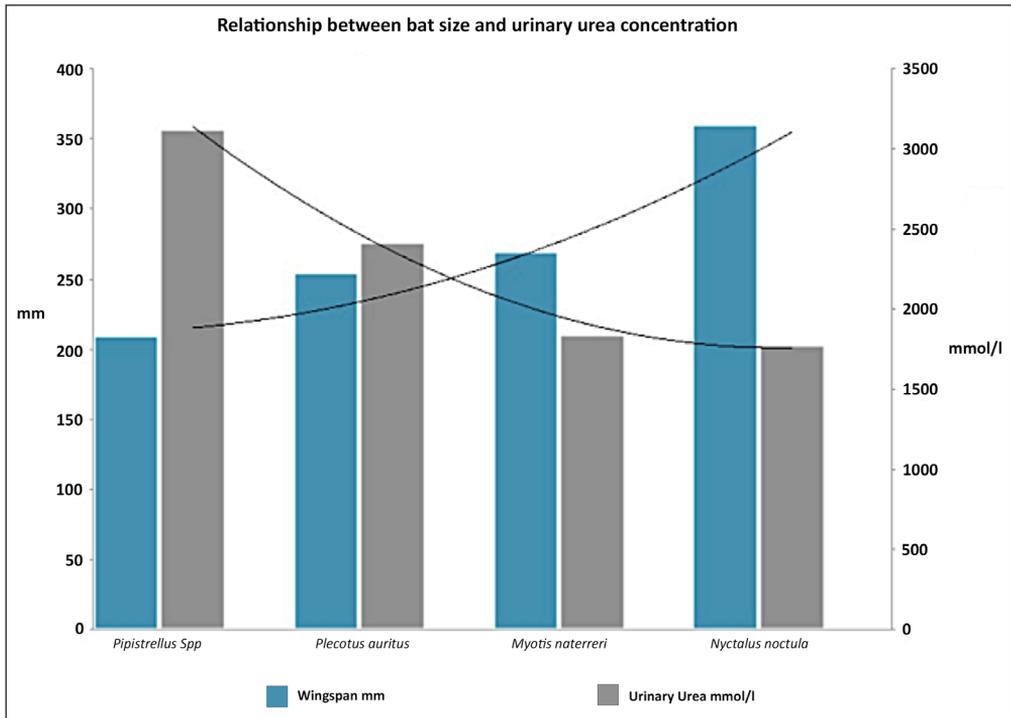
**Fig. 3:** Graph showing the inversely proportional relationship between bat size (represented by wingspan in mm) and urea concentration in mmol/l. To further highlight the relationship, polynomial trend lines are shown for both wingspan and urinary urea.

What is most striking about the data is that the concentration of the urine is inversely

proportional to the size of the bat, with larger bats producing more dilute urine. **Fig. 3** shows the relationship between bat size (represented by wingspan) and urea concentration - the relationship between the two parameters can clearly be seen. If the solutes detected are found to play a significant role in deterioration mechanisms, then clearly their relative abundance in the urine of different species of bat will be a factor affecting the levels of deterioration that might be expected from roosts of different species.

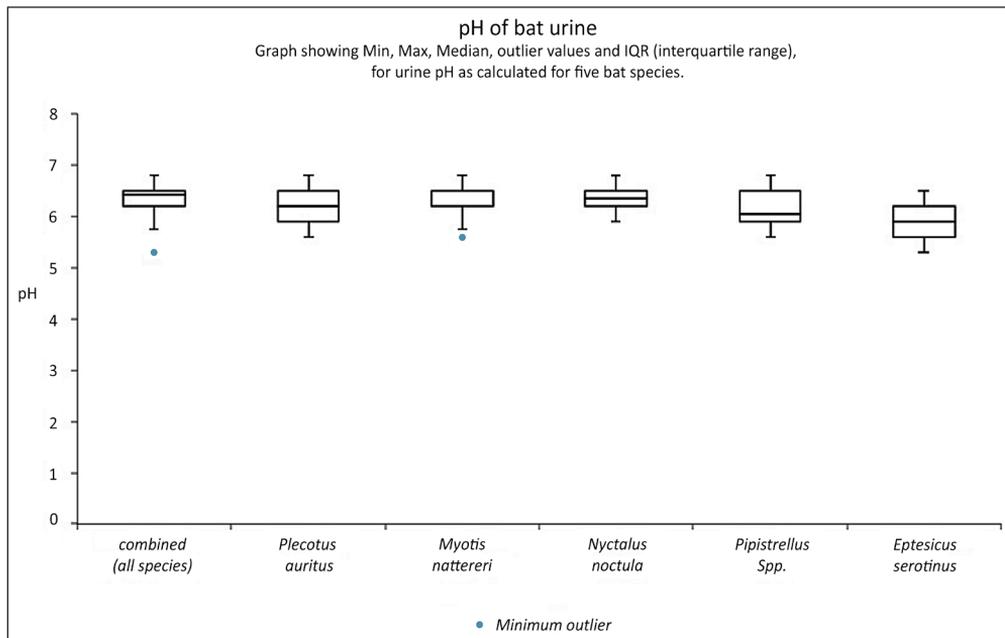
**Fig. 4:** Median Dq plot showing urine pH ranges obtained for five UK bat species. The graph is a “box and whisker” plot. The “whiskers” show the minimum and maximum pH values recorded for each species, the interquartile range ( $Q_3-Q_1$ ) shows the distribution of the middle 50% of the data points and is represented by the “box”, the median value shown by the horizontal line appearing inside.

four species listed above). A combined total of 73 individual pH readings were recorded (**Fig. 4**). pH measurement was conducted on my behalf by licensed bat workers, measurements were taken from fresh urine collected as before from captive bats.

As can be seen, pH ranges for all species tested are broadly similar with a total range for all readings between pH 5.3 - 6.8. Technically speaking all these values fall within a pH range that would be described as acidic, however to provide some context, bottled drinking water sold in the U.K. has a pH that ranges from 4.2 – 8.7 depending on source (Bucksc, 2005) and de-ionised water used in conservation laboratories commonly has a pH of 5.5. Therefore, while the pH of bat urine is acidic, it is only mildly so. Although it should be noted that long term exposure to mildly acidic solutions can be problematic for some materials (for example calcareous stone), my findings do not

support the popular perception that it is the highly acidic nature of bat urine that is the significant and major factor in deterioration mechanisms.

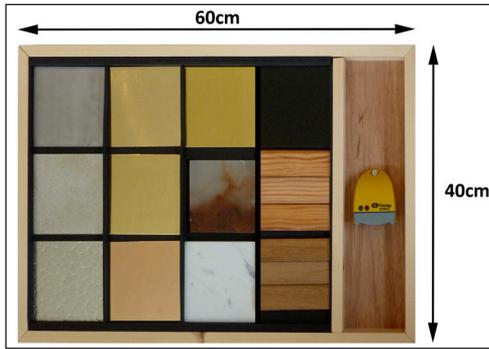
**Fig. 5:** Sample board prior to deployment and positioning of protective elements to partly cover the test samples, and showing the data logger.

The sample boards consisted of wooden trays 60cm x 40cm holding prepared samples of 10cm x 10cm each (Fig. 5). The design allowed for samples to be partly covered so that a section of their surface was protected thus providing a control specific to each individual test material. Each tray carried a data logger used to record relative humidity (RH) and temperature for the duration of the exposure period. This was considered important as temperature and RH would likely play a role in corrosion cycles, rates of reaction and the effect of salt crystallisation within porous substrates.

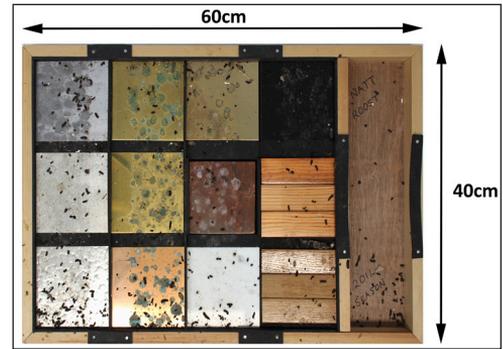
**Fig. 6:** Phase 1 Sample board after retrieval, the effect of bat droppings and urine on the test materials is readily apparent.

This aspect of the work represents a two-year cycle of experimental work, and has generated a dataset of 84 different sample surfaces on which subsequent analysis can now take place. While a full analysis of the test samples has yet to be undertaken, there are some interesting preliminary results. Of foremost importance is the fact that the deterioration seen on the test samples is directly comparable to that observed *in situ*, for example in the case study churches, with corrosion of metal surfaces, staining of porous materials, and the distinctive white spotting resulting from urine deposition on organic coatings (such as polishes) all seen on the test samples (Fig. 6). From initial observations it can also be seen that

investigation should focus not only on the effects of urine and droppings individually, but also on their effects in combination as it appears that this can affect both the type of corrosion seen on metal surfaces and the staining observed on porous materials.
