Specification for work:

Heritage Assessment of Significance and impact of bats on project churches involved in the Bats in Churches Project

ANNEX 3 Example statement of significance

All Saints, Wrabness, Essex

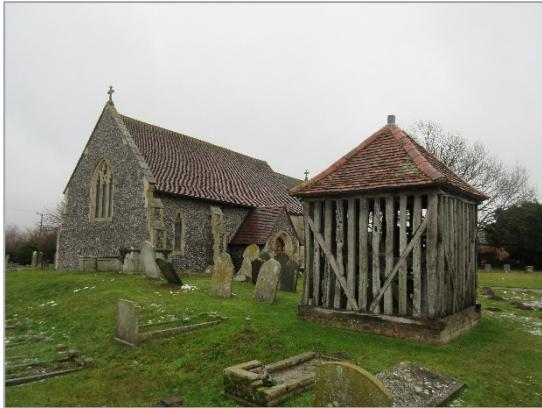
From SW, with bell cage in foreground

The church is of twelfth century origin, but has been much rebuilt over the years. It is built of septaria rubble, mainly cement-rendered, with some red brick patching and limestone dressings. The roofs are plain tiled. The plan is simple, consisting of an aisleless nave with porch to the south and vestry to the north, and a square-ended chancel. There is no tower, but Morant reported in 1768 that there was 'formerly a stone tower, with 5 bells; now only 2, in a wooden turret'. The two bells are now housed in a freestanding timber framed bell cage in the churchyard, southwest of the church (photo top left at top of report).

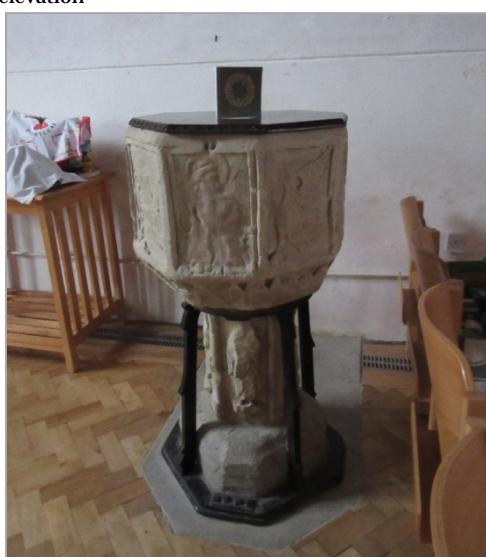
Font

In recent years the nave pews have been mostly removed (two survive at the west end) and replaced with individual chairs. The nave floor has been relaid with woodblock and a modern kitchenette installed at its west end. The font (photo bottom left above) is now placed near the vestry door, representing at least the third relocation of this fragile piece, whose carved figures of the four evangelists were mutilated after the reformation, and which is now crudely held together with iron clamps. The chancel retains its late Victorian encaustic tiled floor and plain benches.

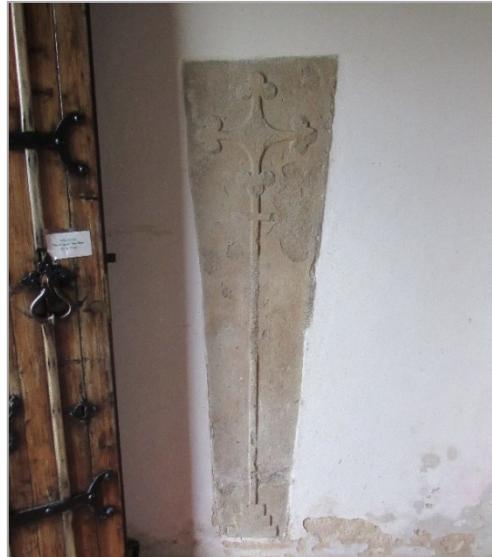
Medieval coffin lid re-set in S porch

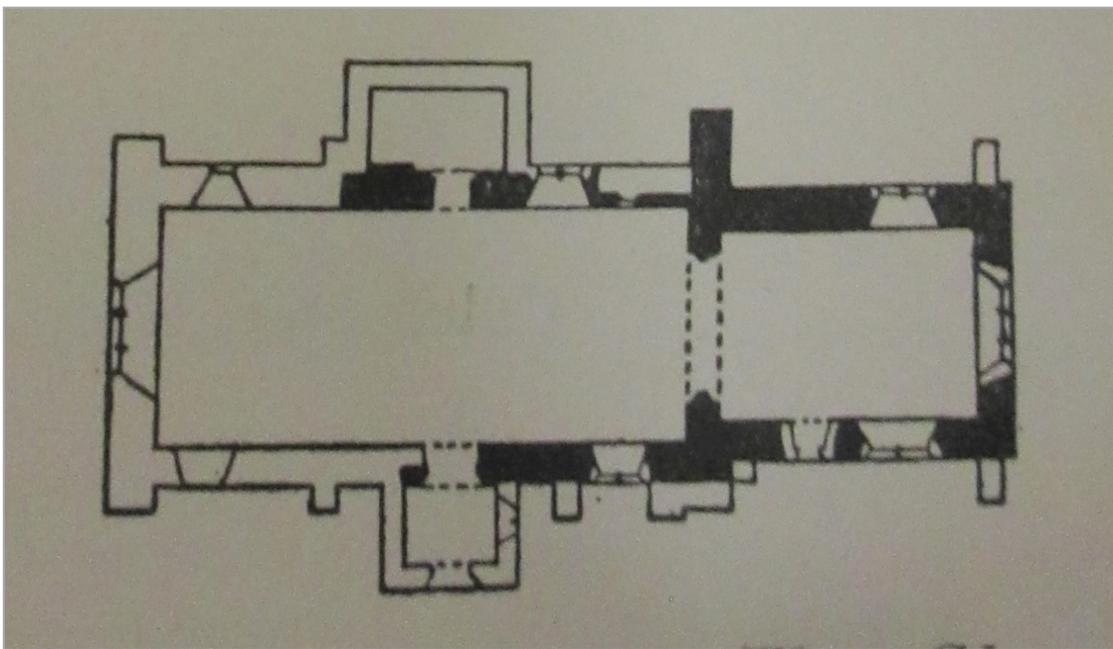
Figure 1: Plan (RCHME, 1922)

The oldest part of the structure are those parts of the nave coloured black in the plan at figure 1. These are twelfth century in origin and include the north doorway, now within the vestry (not seen). The south doorway was mostly rebuilt in the fifteenth century, with fleurons and shields in the voussoirs; however part of its original twelfth century arch and label remain. The hammerbeam roof of the eastern bays of the nave (unusual for Essex) may be contemporary with the south door. The chancel was rebuilt in the fourteenth century, and again after a partial collapse on Easter Sunday 1697. A framed extract from the parish register hanging in the church records that the chancel roof fell in, bringing with it a large part of the walls; the chancel was rebuilt, 'new ceiled, the walls wainscoated, the communion table devoutly railed, the new floor paved and three convenient seats now built, of all which there was non before'. These furnishings were lost in the 1893 restoration or before, and the chancel now has a boarded ceiling.

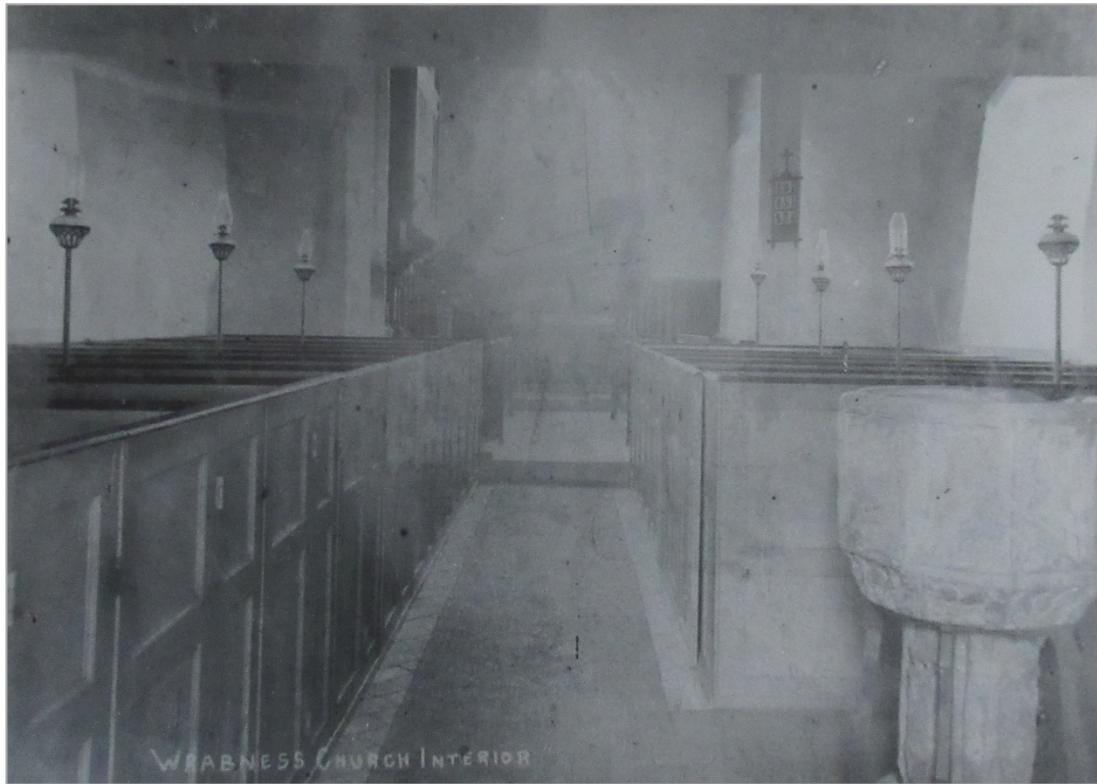
Figure 2: Late

nineteenth-century photograph of interior before restoration

An undated, late nineteenth-century photograph hanging in the church (figure 2) shows the interior before its early twentieth-century restoration, with high box pews, oil lamps and a brick floor with runner in the central alley. At that time the late medieval font was placed near the south doorway.

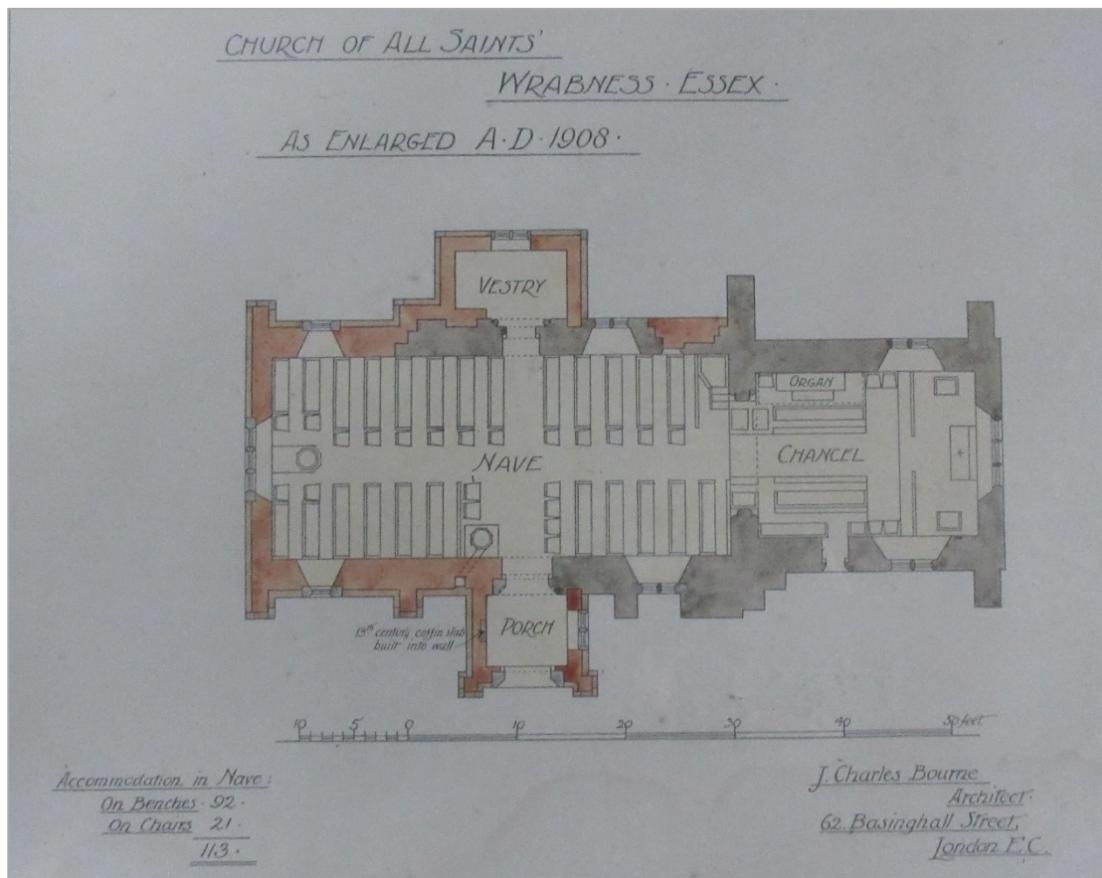
Figure 3: J. C.

Bourne plans for enlargement, 1908 (framed drawing hanging in church)

The chancel again was restored in 1893, by the architect J. C. Bourne of London. In 1907-08 Bourne carried out a more extensive restoration and enlargement (figure 3), with the nave extended westwards, the south porch (previously a vestry) rebuilt and a new vestry added to the north of the nave. The builders were James Richard Sage and Frederick Cutting. A thirteenth century coffin lid (photo bottom right above), which had been uncovered in the chancel during its 1893 restoration, was reset in the wall of the rebuilt porch. The new additions were faced in flint, contrasting with the largely rendered finish of the older elevations.

Bourne's plans show a conventional post-Tractarian layout, with the font at the west end, pews and some chairs on either side of a central alley in the nave and choir stalls and an organ in the chancel. The restoration provided seating for 113 people in the nave, 92 on benches and 21 on chairs.

- At the west end, a framed drawing by J. C. Bourne showing the 1908 enlargement and seating plan (figure 3), and a brass plaque commemorating that restoration and enlargement.

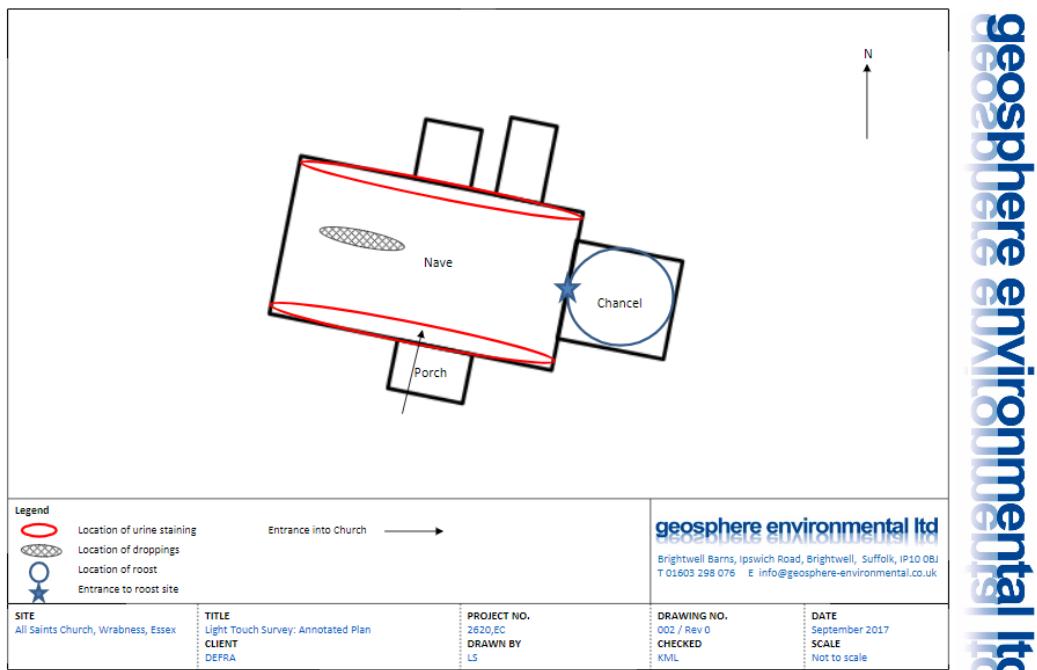
Figure 4: LTS plan, showing bat activity and impact

The LTS noted some droppings from brown long-eared bats, and extensive staining of the walls by urine, particularly in the nave (figure 5). Very minor damage to flooring and monuments was noted. It reported that most people in the parish were happy to share the church with bats.
